Appendix A. Quantitative Fault-Slip Data and Field Descriptions for 1,158 Faults in the Sterling mine, Ogdensburg, Sussex County, New Jersey

Earl R. Verbeek and Marilyn A. Grout

2025

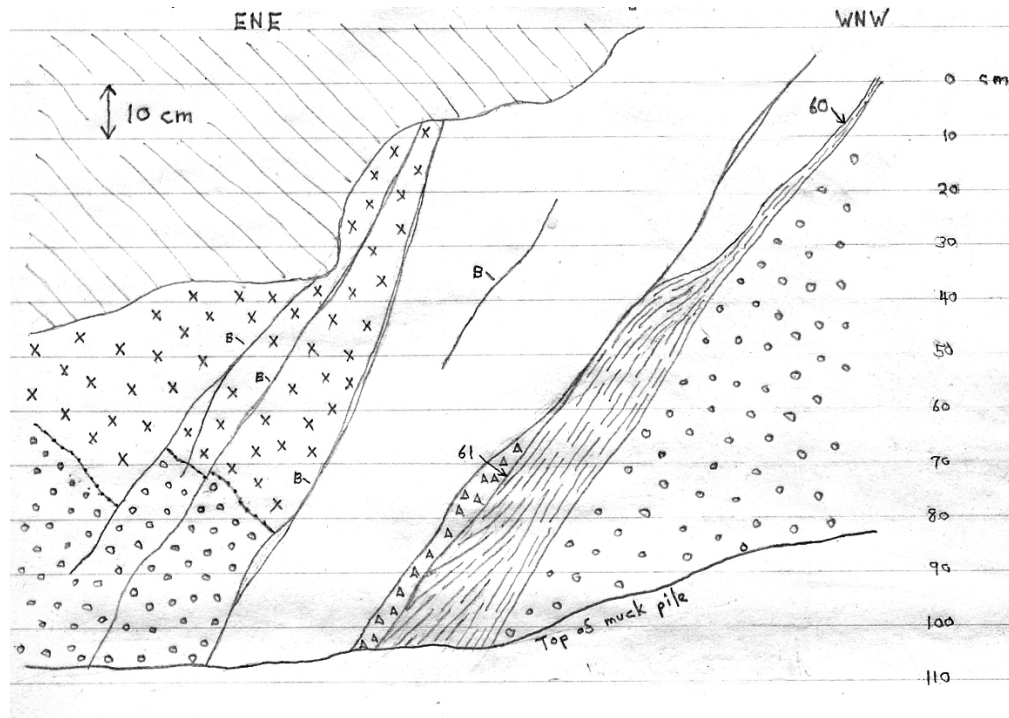
The sketch map below is a projected vertical section, looking NNE along the strike of the fault zone at Station 10. The apparently anomalous offsets of the footwall ore contact are probably due to multiple episodes of movement in different directions, one of them with a strong lateral component (e.g., fault no. 500). These faults are known to have been repeatedly reactivated. In the sketch, the numbers 60 and 61 show the sites of measured slip indicators for faults nos. 499 and 500, respectively. Note that black ore on the west is here faulted against brown ore on the east. This is probably an up-plunge segment of black ore along the footwall of the East limb, here faulted northward against brown ore. Nearby, just to the south of this fault, along an unfaulted portion of the footwall of the East limb, the two grade laterally into each other.

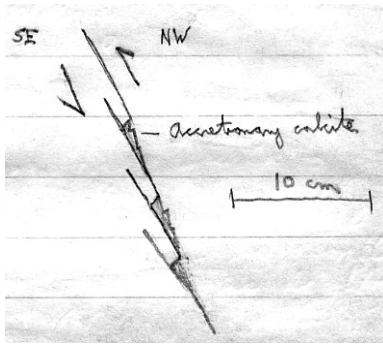
Comments: NW-dipping segment of Nason fault in high-grade franklinite-willemite ore. Fibrous accretionary calcite locally coats a polished fault surface developed within the mylonite zone. Step faces in this calcite indicate SE side of fault is the downthrown block.

Note: The sketch at left, a vertical SE-to-NW section, shows the geometry of the fault here. In detail the fault surface consists of multiple *en echelon* segments, each of them dipping at a slightly shallower angle than the mean fault surface. These rock-cut fractures, all of which can be traced into the footwall rock for several centimeters or more, are scored by delicate scratches parallel to the fibers in the accretionary calcite above. The accretionary calcite forms wedge-shaped masses along the steps from one *en echelon* fault segment to another. It thus forms ribbonlike masses on the fault surface, each ribbon being thickest (up to 1 cm) at its upper end and tapering to zero thickness at its lower end. The fibers within the

accretionary calcite are inclined at slightly steeper angles than the mean fault surface, consistent with the NW-side-up, SE-side-down sense of slip. Thus, on the footwall block (left block as shown in sketch), the rock-cut steps on this fault surface face *downward*, while the step faces in the accretionary calcite face *upward*. Given that the Nason and related faults have overall steep SE to vertical dips, this NW-dipping portion of the fault was in an overall dilational field as fault slip occurred.

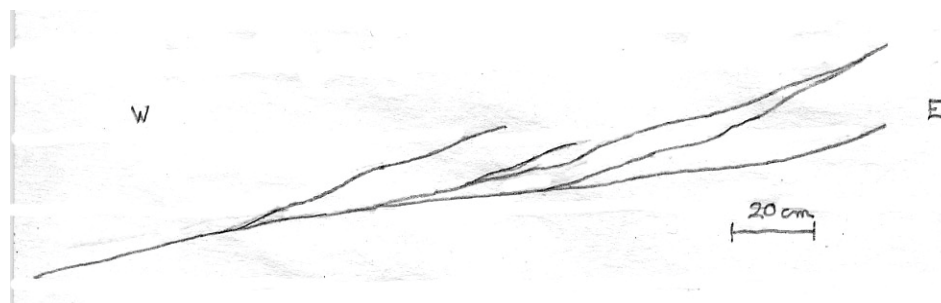
Fault no. 854

Comments: Epidote-coated fault surface bearing mechanical scratches due to fault slip. This is the fault that produced most of the zeolite specimens collected recently (late 1990) by John Kolic. The fault cuts pyroxene-calcite-feldspar(?) gneisses of highly

variable grain size (0.1-3 cm). Above is a field sketch of this fault, which plays into multiple strands. Epidote lines the fault surfaces. Sphalerite, minor galena, calcite, and zeolites occupy open spaces in the areas between the fault strands, where minor brecciation occurred. The zeolites encrust the calcite and are probably the latest minerals to be deposited there.

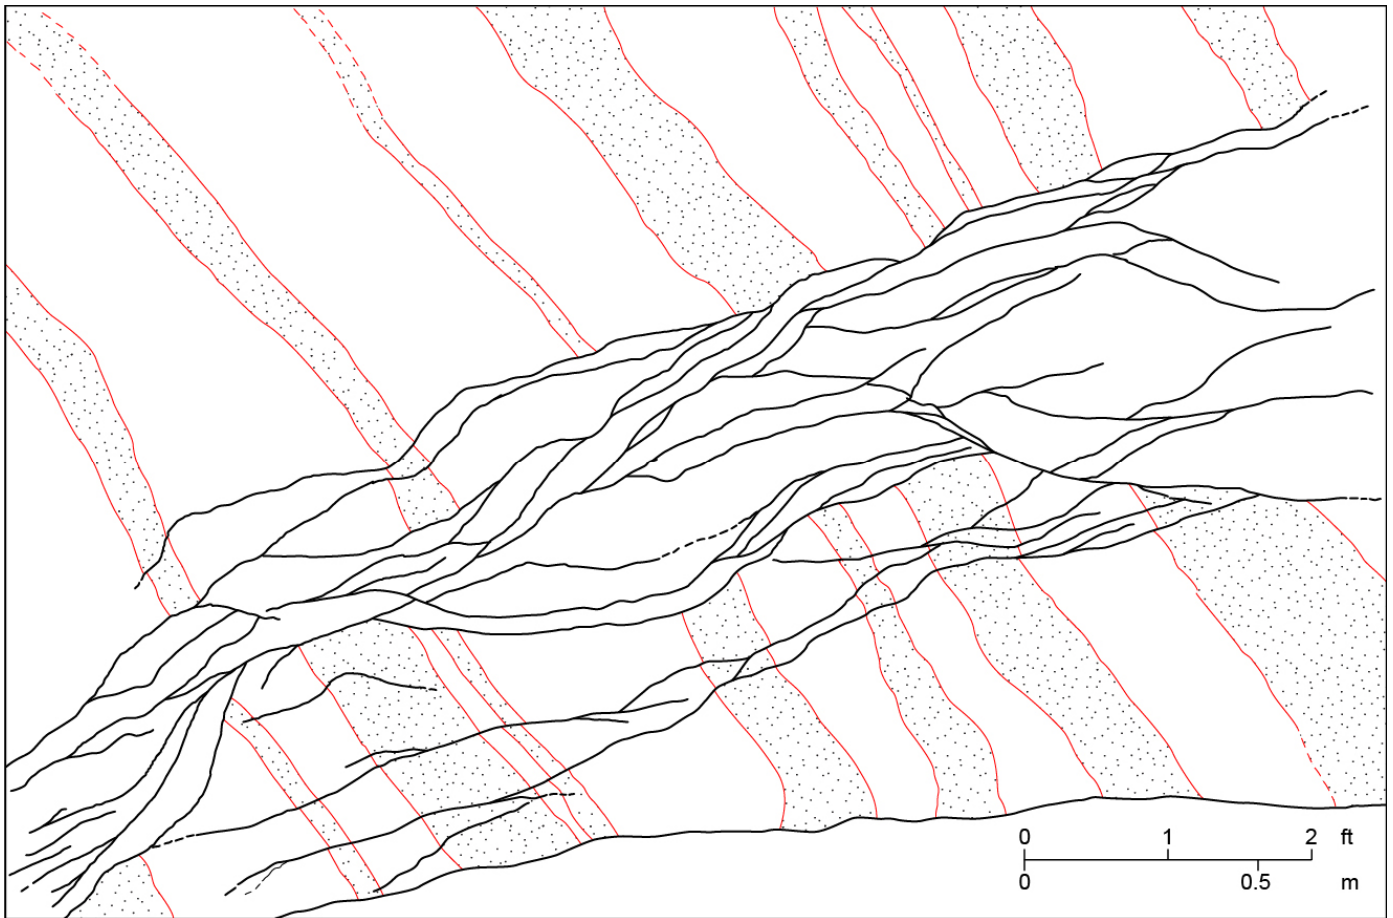
The fault strands as mapped in the sketch include both discrete surfaces, commonly veined with secondary hydrothermal minerals, and thin zones of fault breccia within which no discrete fractures can be seen. The breccia masses along the faults are lenticular and in some places occupy the entire space between two strands of the fault zone. Most are 1-3 cm thick, but locally, some are 7-8 cm thick. Much of the breccia is cemented by sphalerite. Most of the sphalerite is medium-grained and pale honey brown, but locally this grades into cryptocrystalline, reddish-brown sphalerite of the type sometimes mistaken for friederite. Where breccia is absent, many of the fault surfaces are lined with fine-grained, ivory-colored carbonate and secondary willemite to form veins generally ranging in thickness from 1 mm to 1 cm, but locally as much as 2 cm. “Calcozincite” is rare *within* most of the fault zone but is a prominent component of slip surfaces that cut the layered zincite ore both above and below the main part of that zone.

On the next page is a drawing of the braided fault zone at this locality, as revealed in a near-vertical wall of the stope. The fault zone was first sketched in the field, using a steel tape to measure distances to the nearest one-half inch. Later, a set of numerous overlapping photographs (35-mm color slides) from several individuals (Bernard Kozykowski, Steven Misiur, Earl R. Verbeek) was used to add detail by enlarging each slide and projecting it onto the base map. The plane of the sketch is S30W (left) to N30E (right); the view direction is thus about N60W. As noted in sketch, measurements are in feet. The view direction is at only a modest angle from the average direction of slip during the initial stage of movement on these faults. The stippled layers in the drawing depict zincite-rich ore.

In addition to sphalerite, chalcopyrite, bornite(?), and their green and blue alteration products are also components of the local fault-vein system, but only within the coarse-grained marble, not where the fault cuts the ore. The mineralogy of the veins, then, is highly dependent on host-rock lithology. Some of the veins are not completely sealed but contain small, lenticular cavities lined with tiny crystals of several different minerals, as yet unidentified.

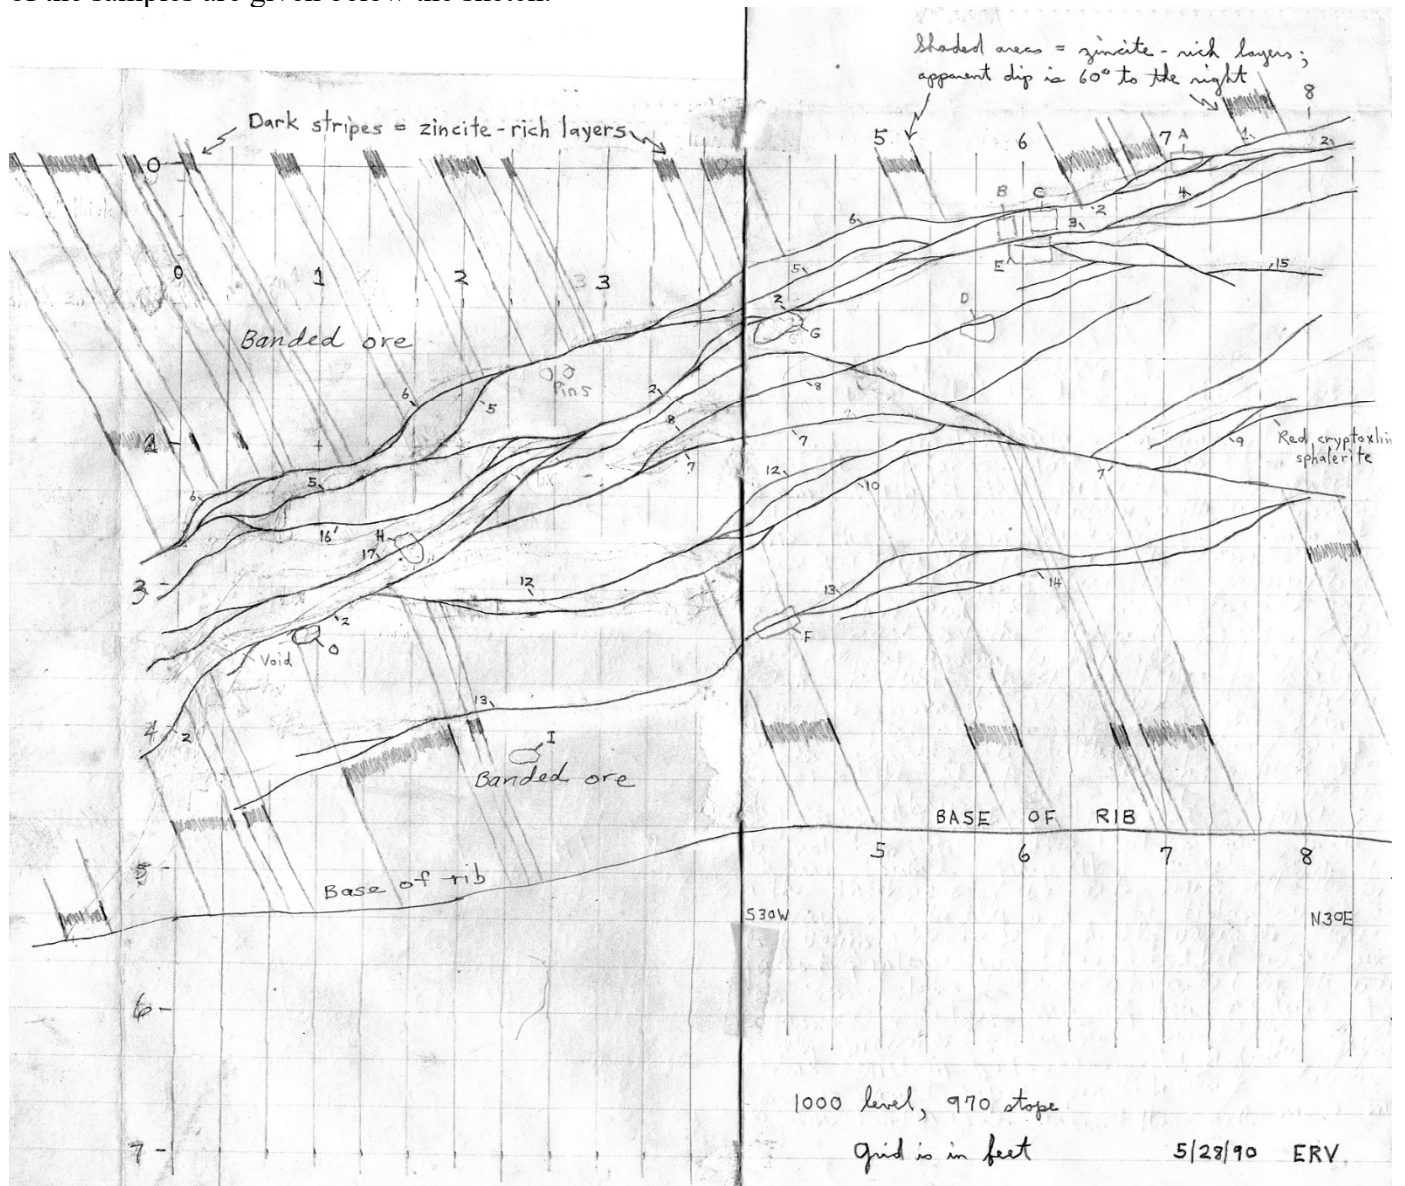
Shown below is our original field sketch of this fault zone. The lettered areas on the sketch indicate places where samples were taken for later study. Selected faults are indicated by small numbers. Brief descriptions of the samples are given below the sketch.

- A. Thin vein through this sample is fault 1; fibrous base is fault 2. Arrow points up and is on front face of sample.
- B. Top vein is fault 2; bottom is fault 3; breccia cemented by sphalerite between.
- C. Same as B but taken a few inches farther NE; fine example of sphalerite-cemented breccia.
- D. Thin brown vein near top edge of sample is fault 8; brown is serpentine(?) with secondary willemite.
